Upper Penitencia Creek Improvement Project
Year -2 (2014) Monitoring Report

Project # 3518-03

H. T. Harvey & Associates

17 April 2015

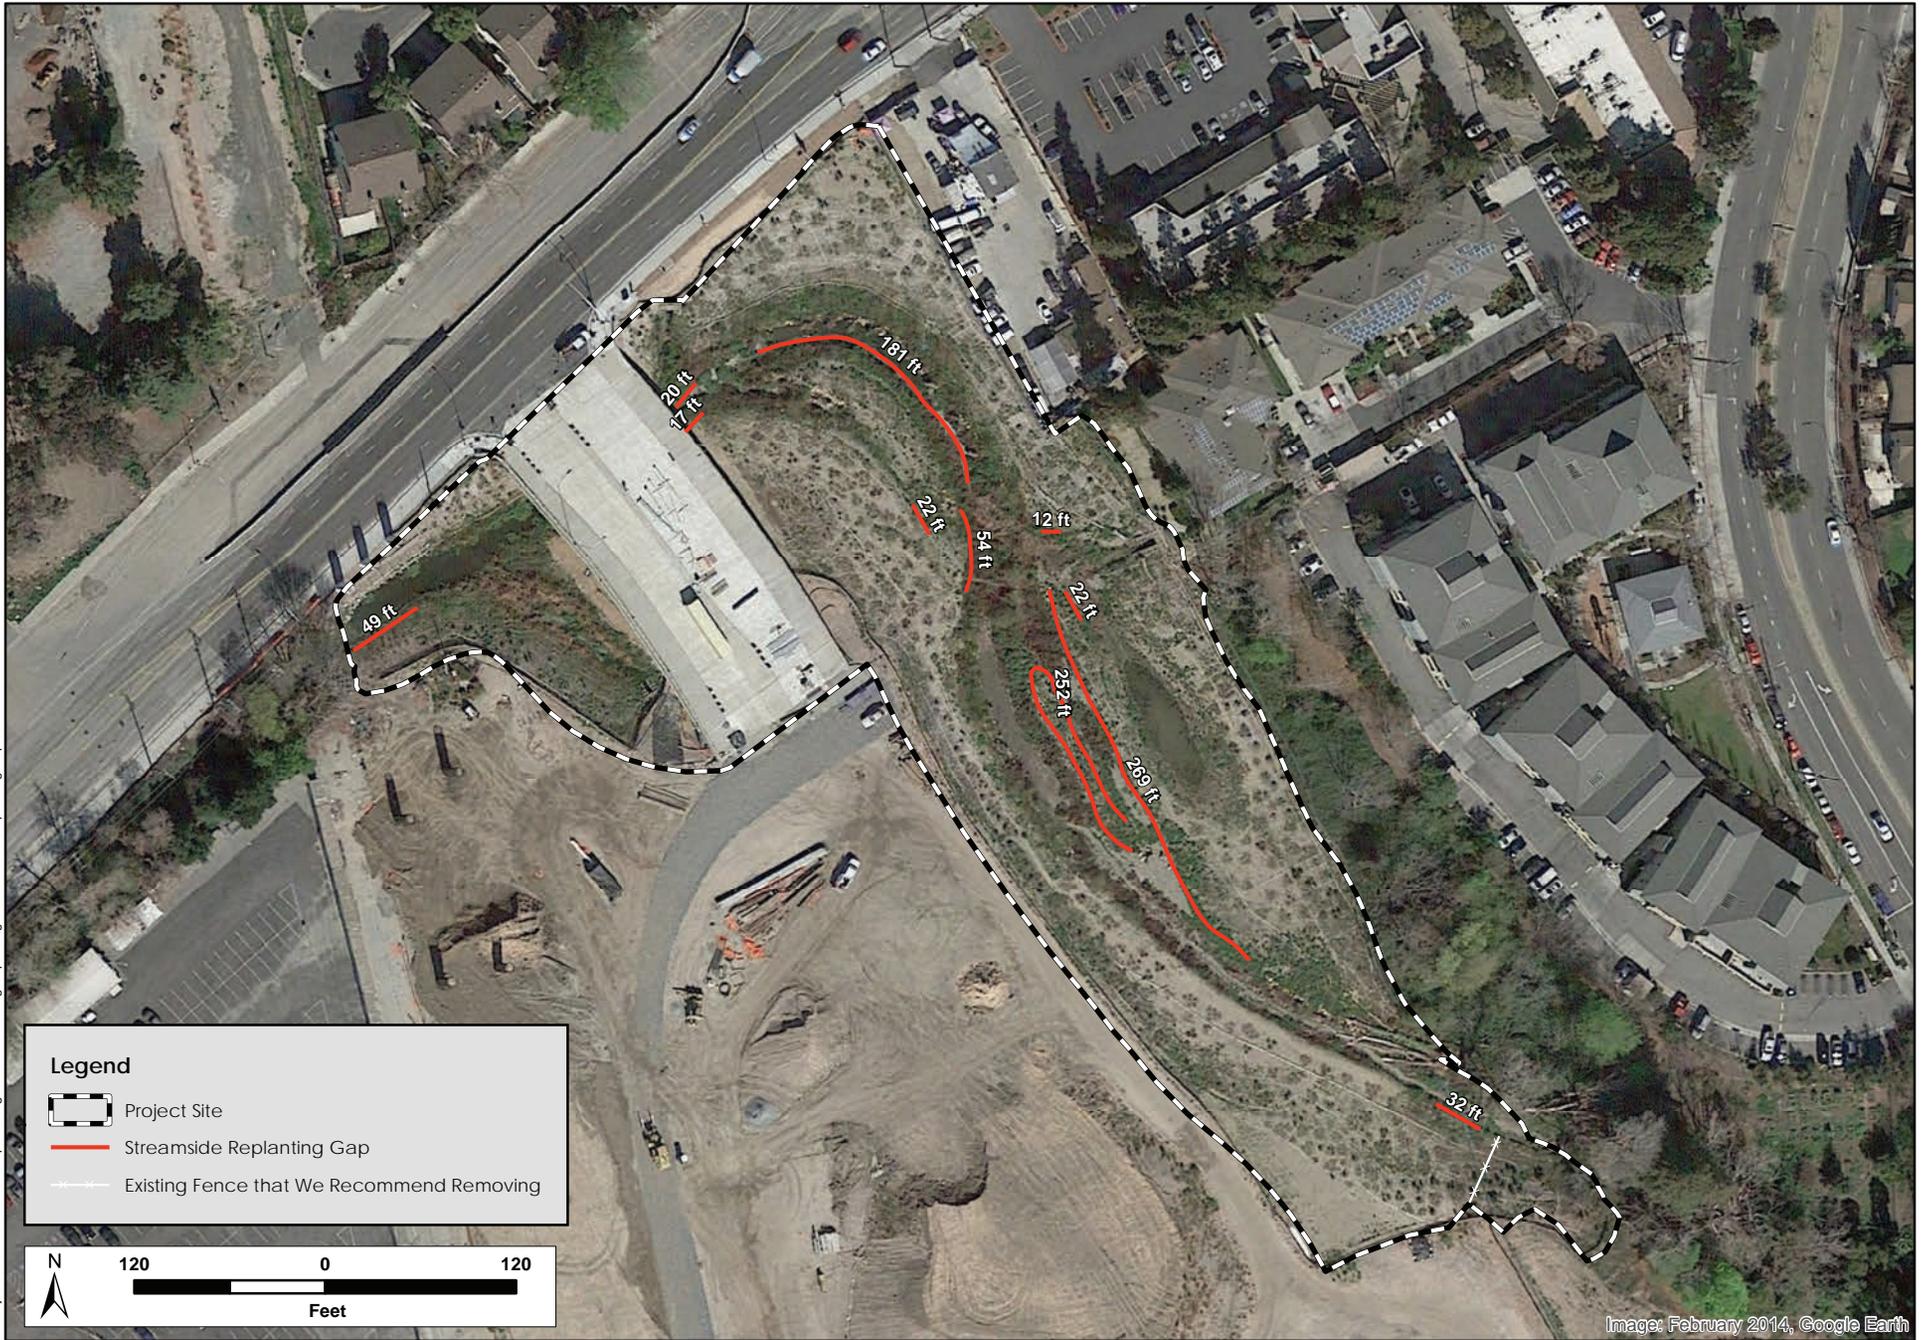
Figure 7: Streamside Replanting Gap Locations
Upper Penitencia Creek Improvement Project
Year-2 (2014) Monitoring Report (3518-03)
April 2015

Cuttings were successful in forming canopy throughout the majority of the Streamside Area. However, several canopy gaps of substantial length were present in the Streamside Area. The total length of Streamside Area canopy gaps totaled 631 feet, resulting in a recommended total of 105 cuttings to be installed at 6-foot centers. Figure 7 shows the locations of the Streamside Replanting Gaps and Table 7 presents recommended replanting quantities for these Streamside Replanting Gaps.

Scientific Name	Common Name	Recommended Replanting Quantity
<i>Populus fremontii</i>	Fremont cottonwood	20
<i>Salix laevigata</i>	red willow	60
<i>Salix lasiolepis</i>	arroyo willow	25
Total		105

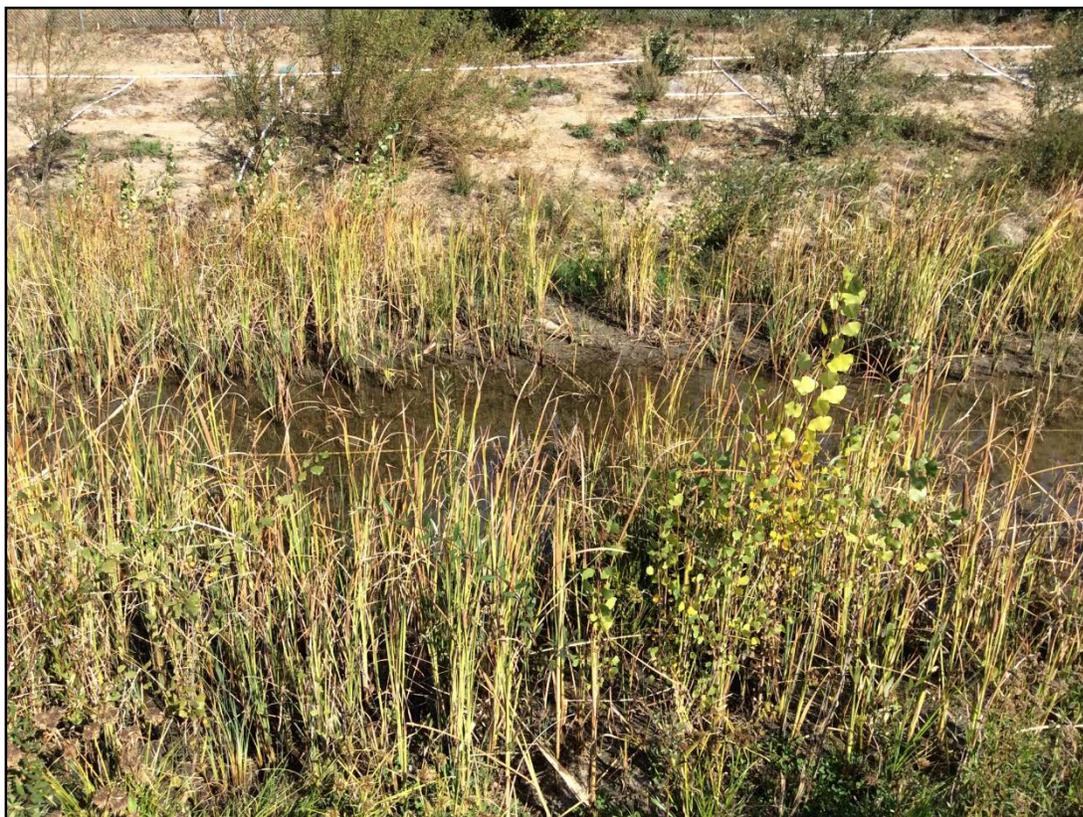
Wetland 1 is approximately 104 ft by 32 ft with an approximate surface area of 3300 ft². Photos A and B are representative photographs of the state of Wetland 1 in October 2014. The wetland supported standing water with low turbidity in October 2014. The plant community of Wetland 1 was stratified into distinct concentric rings of vegetation spanning a gradient from perennial, emergent wetlands at the lower elevations, to seasonal wetland vegetation along the upper slope. The lowest elevations of Wetland 1 were bare of emergent vegetation. The lowest vegetation consisted of emergent cattails (*Typha* sp.) that are increasing in cover through lateral expansion. Non-emergent vegetation located upslope from the cattails included non-native rabbitsfoot grass (*Polygomon monspeliensis*), planted irisleaf rush (*Juncus xiphioides*), naturally recruited and planted marsh baccharis, and planted willows (*Salix* spp.). The vigorous growth of willows indicated that they were likely rooted into groundwater. In the upper banks of the wetland, mulefat (*Baccharis salicifolia*) and Fremont cottonwood (*Populus fremontii*) plantings showed new growth and good health.

Photo A. Side view of Wetland 1 from the middle of southwest bank

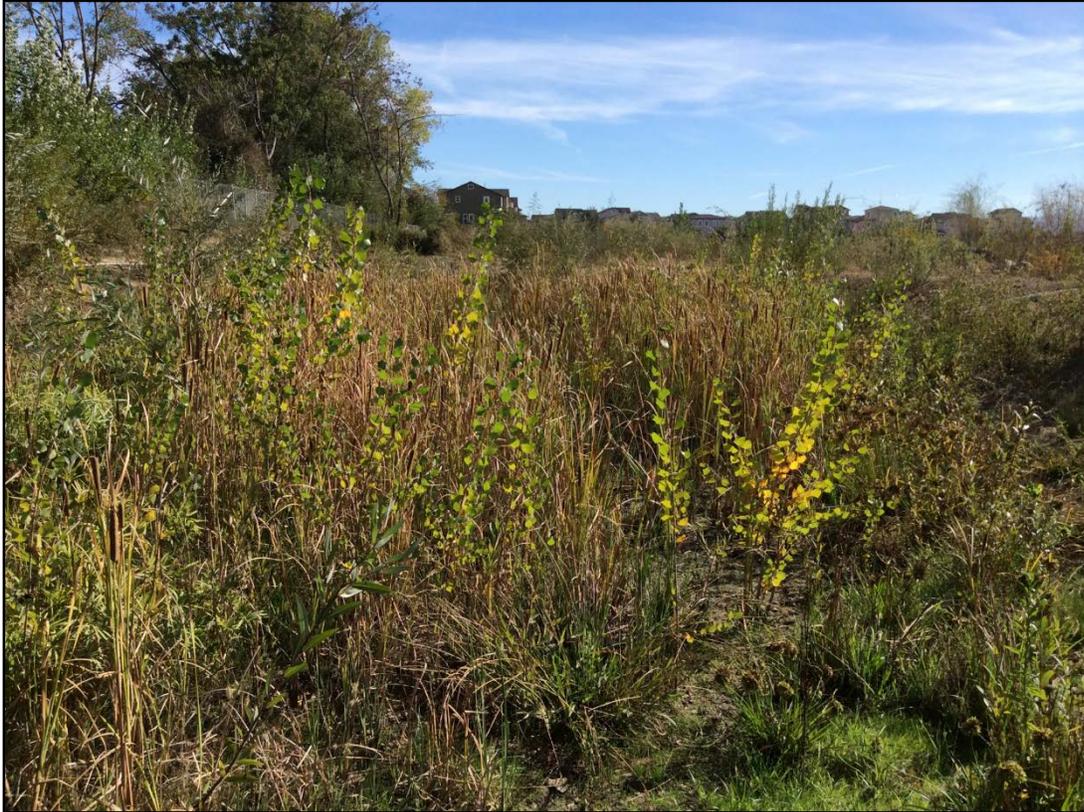
Photo B. View looking southeast down length of Wetland 1 from northwest corner

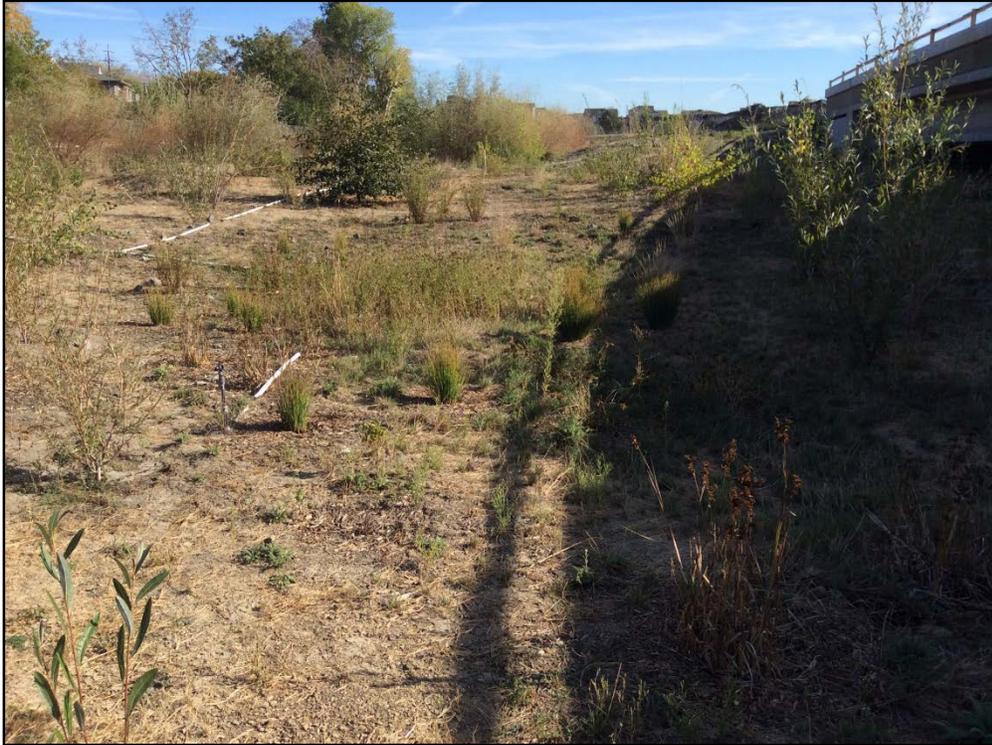
Wetland 2 measured approximately 35 ft by 20 ft with an approximate surface area of 700 ft². Photos C and D are representative photographs of the state of Wetland 2 in October 2014. There was no standing water observed in Wetland 2 in October 2014. Since Wetland 2 was drier than Wetland 1, the Wetland 2 plant community was composed of seasonal wetland vegetation, with little to no perennial, emergent species. Relatively dense, native-dominated seasonal wetland vegetative cover was observed in the bottom of Wetland 2; the plant community was composed primarily of tall flatsedge (*Cyperus eragrostis*), irisleaf rush (*Juncus xiphioides*), meadow barley (*Hordeum brachyanterum*), and marsh baccharis. Non-native bristly ox-tongue (*Helminthotheca echioides*) and burclover (*Medicago* sp.) were also observed at lower abundances in the bottom of the wetland. Vegetation on the wetland banks included plants from the Streamside Area palette such as sandbar willow.

Photo C. View looking south at Wetland 2

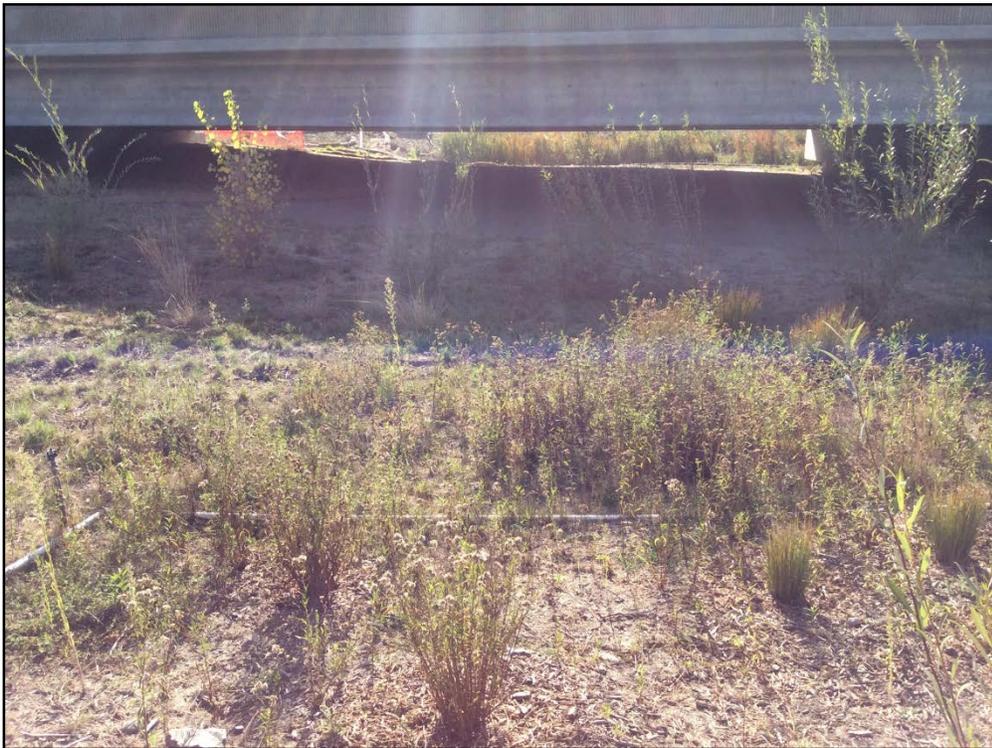
Photo D. View looking west at Wetland 2

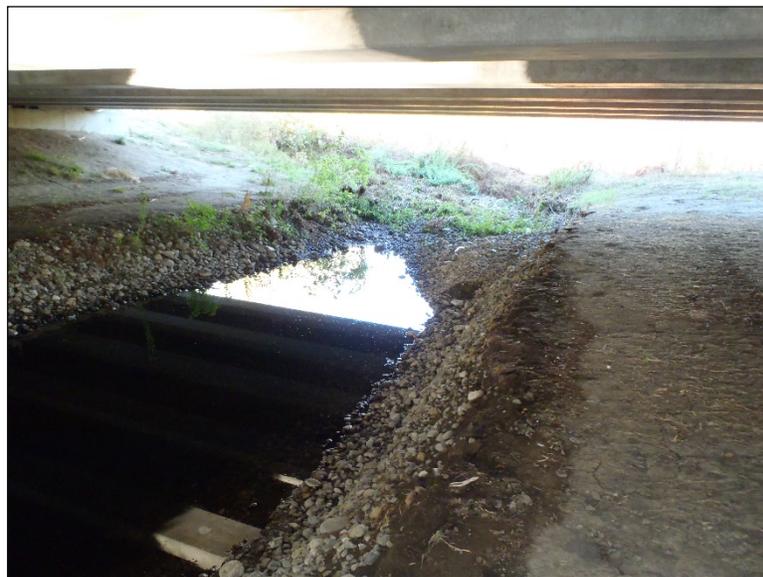
Photo E. Shallow habitat unit with no surface flow (Habitat Unit 4)-fall 2014

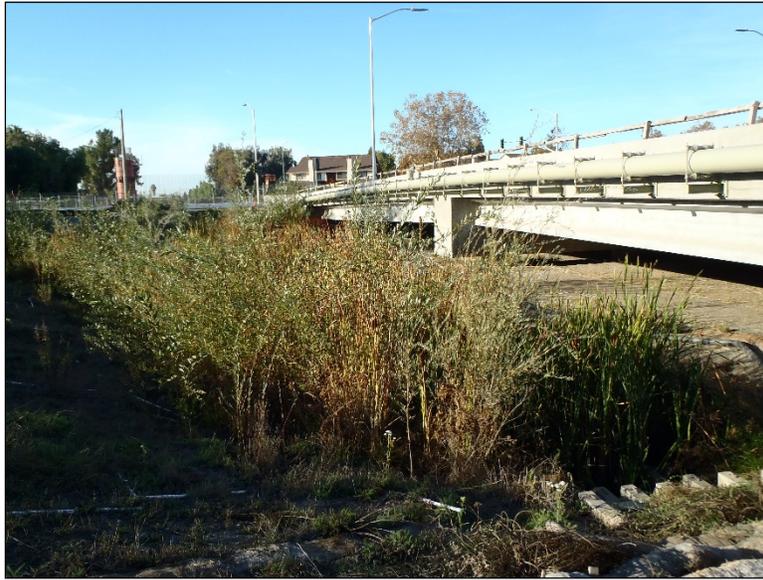
Photo F. Backwater habitat unit with dense emergent vegetation (Habitat Unit 2)-fall 2014

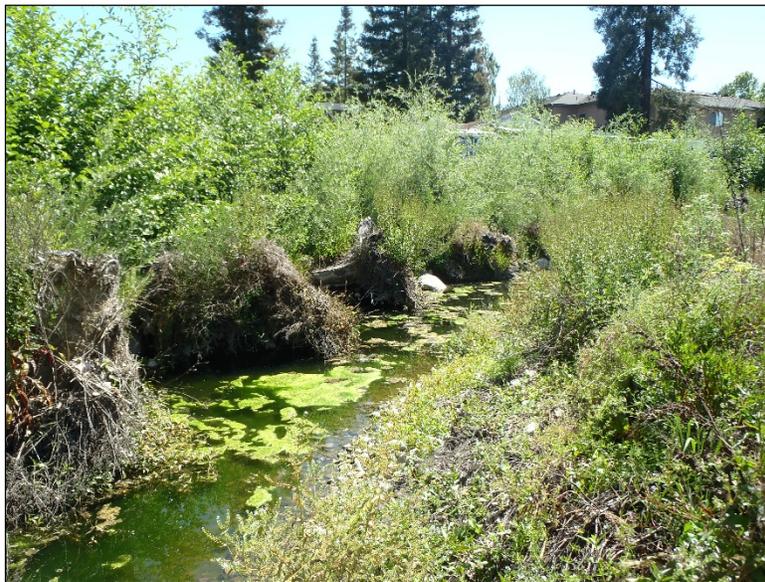
Photo G. Stagnant pools near rootwad restoration features (Habitat Unit 7)-spring 2014

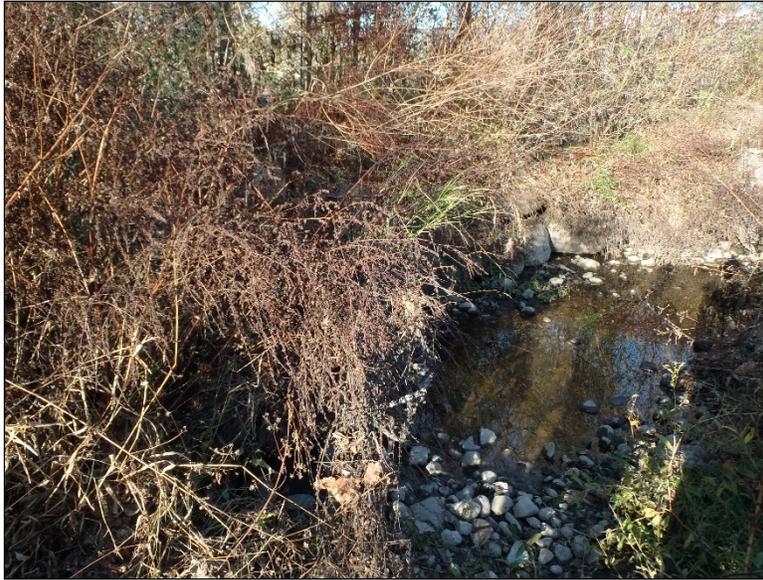
Photo H. Stagnant pools near rootwad restoration features (Habitat Unit 7) – fall 2014

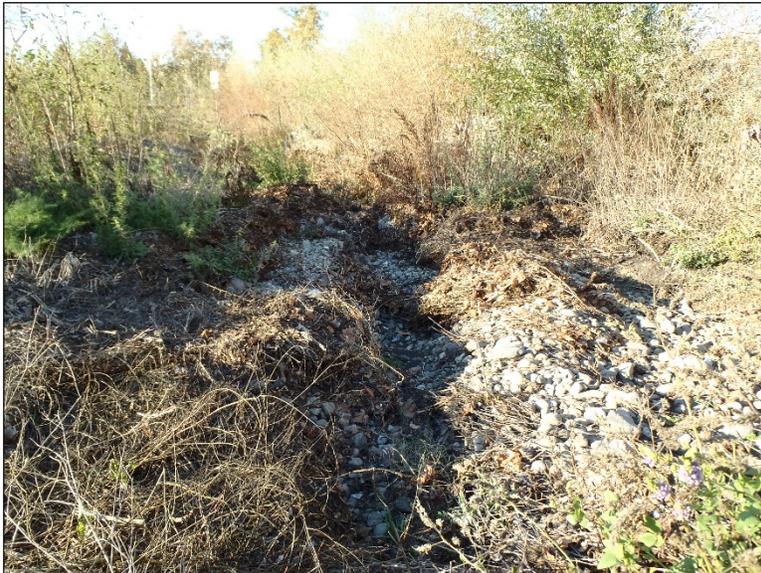
Photo I. Dry habitat unit (Habitat Unit 8)-fall 2014

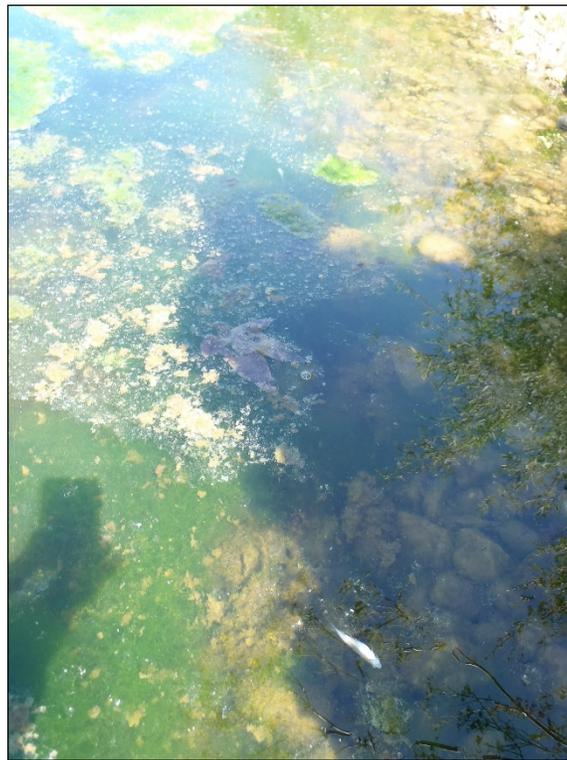
and the project reach. In the 2014 water year, with the exception of three events during which there was continuous flow through the project reach, there was a persistent absence of connectivity to upstream reaches. Adult steelhead access to upstream spawning habitat may have been possible during brief, continuous flow events, but was otherwise prevented by dry reaches at least until after the survey was conducted in November 2014. Flow events occurred earlier in the year than typical juvenile steelhead outmigration (Moyle 2002). The presence of persistent pools charged by subsurface flow may provide critical over-summering habitat in the project site if features are accessible and if water quality is suitable; during HTH's previous Year-1 surveys it was apparent that steelhead were utilizing restoration features (i.e., root wad scour pools) as habitat during low summer flows. However, during Year-2 the water quality in remaining pools was extremely poor; pools were stagnant and choked with algae and emergent vegetation. During spring visits to the project site, dead California roach carcasses were observed on the margins of some pools (Photo J).

Photo J. California roach (dead) in stagnant pool (Habitat Unit 7), spring 2014

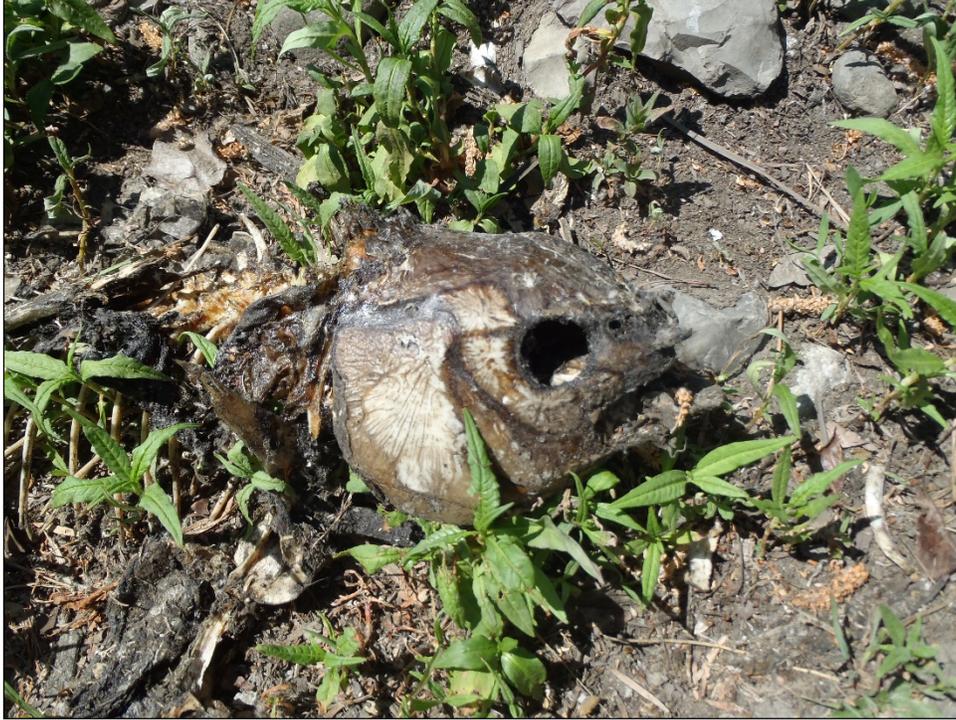
Introduced species. No live introduced species were documented during Year 2. However, in the spring, an unidentified fish carcass that was likely an introduced minnow or carp (Family Cyprinidae) was observed in a dry channel within the restoration site (Photo K). The concentration of fish into pools during low flows may result in high levels of predation on relatively small fish, including juvenile steelhead, by introduced predators. During Year 1 fall 2013 surveys, fish, including introduced species, were concentrated into Habitat Unit 4 (Figure 8) and may have been using this unit as a refuge due to its sheltered location under the newly constructed bridge and its large size; however, in Year 2 surveys, no fish were captured in this unit during investigatory seining or bank (visual) surveys.

Photo K. Unidentified fish carcass in dry reach (likely an introduced minnow or carp (Family Cyprinidae)) – spring 2014
