Upper Penitencia Creek Improvement Project
Year -2 (2014) Monitoring Report

Project # 3518-03

H. T. Harvey & Associates

17 April 2015

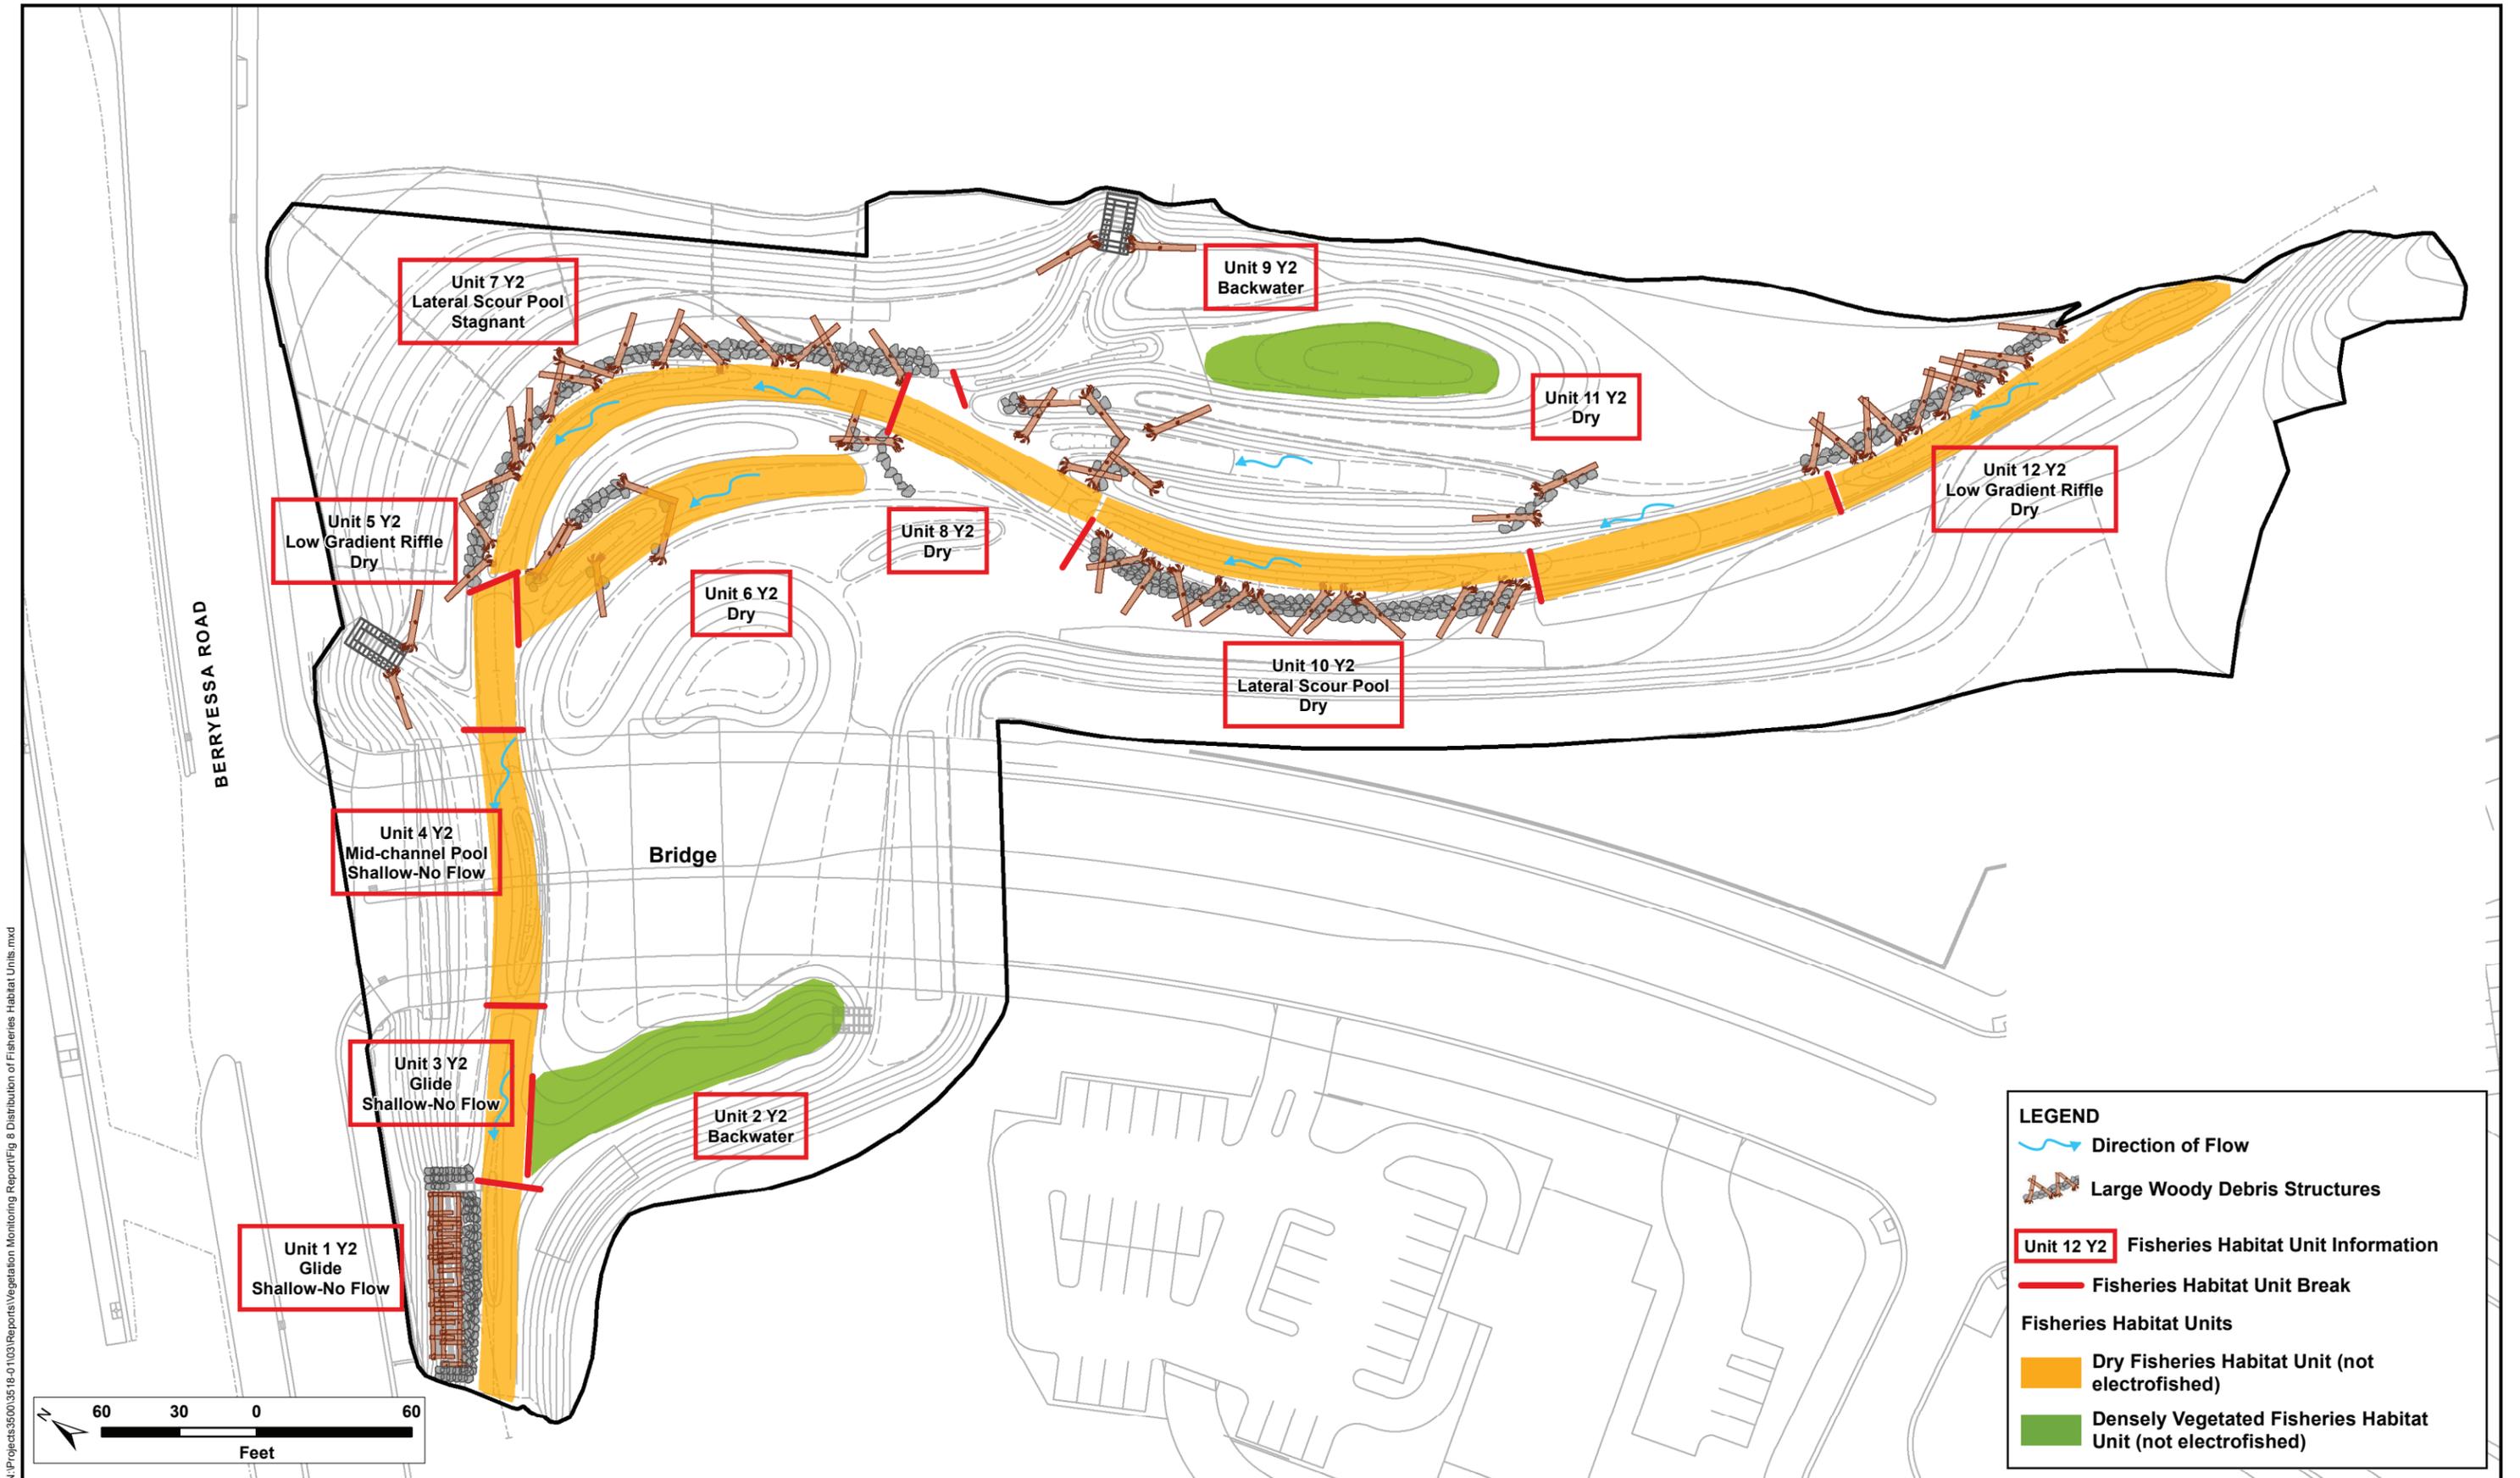
During spring and fall habitat surveys, HTH fish ecologists used habitat names and locations identified in Year 1 for reference when describing the condition of the stream channel in Year 2. Figure 8 shows the plan view locations and habitat units identified in Year 1 and the condition of the habitat units in Year 2. In Year 2, all habitat units in the project site either: 1) contained shallow water with no flow (Photo E), 2) were densely vegetated and filled with stagnant waters (backwaters) (Photo F), 3) contained stagnant pools of water (Photos G & H), or 4) were completely dry (Photo I), (Table 11).

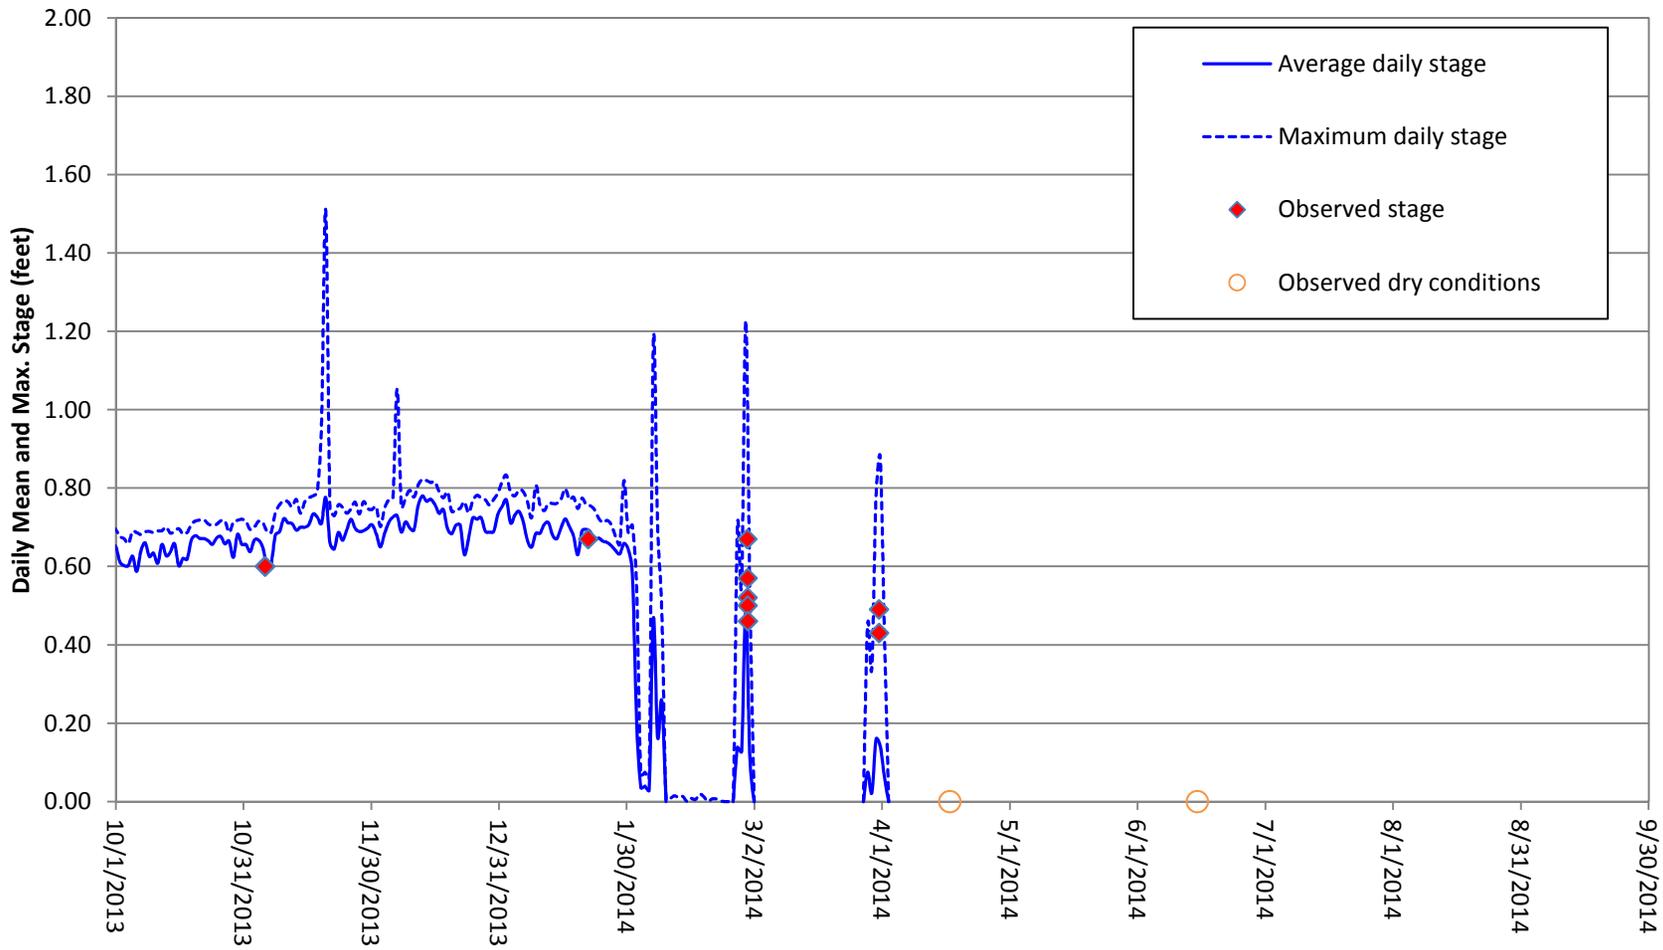
Figure 4.

Daily stage hydrograph: Upper Penitencia Creek at Berryessa Road, San Jose, California, water year 2014. In general, streamflow entering the project reach ceased after January with intermittent streamflow during a few storms in March and April. Dry channel conditions persisted for the rest of the water year with some isolated pools.
